Subject: Lightning Indirect Effects Testing of the T800 PDX System

Our Reference: Lightning Technologies, Inc.
Project No. LTI-4039

Mettler-Toledo, Inc.
1150 Dearborn Drive
Worthington, OH 43085

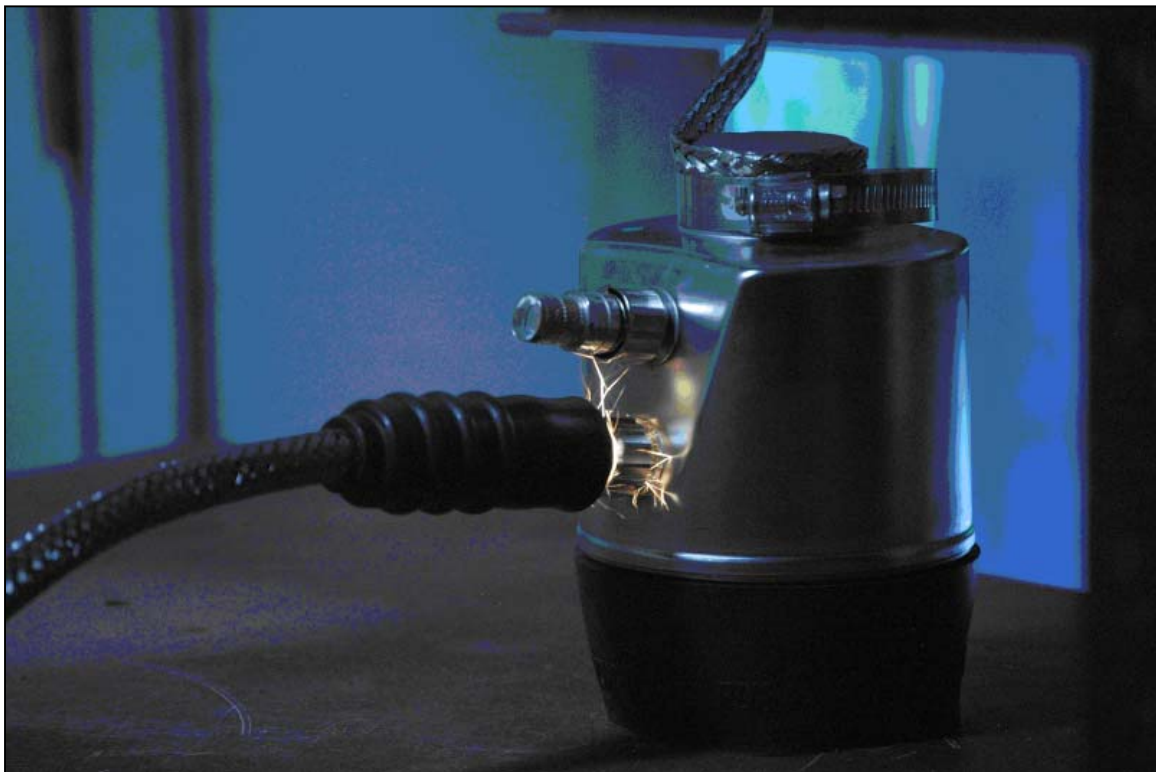
Figure 1 – Test Area Setup

The test setup consisted of injecting lightning surge currents into the shield of the interconnecting cable between the POWERCELL PDX load cell on one end and the T800 Terminal on the other. Figure 1 shows a 30 kA surge current at the POWERCELL PDX load cell.

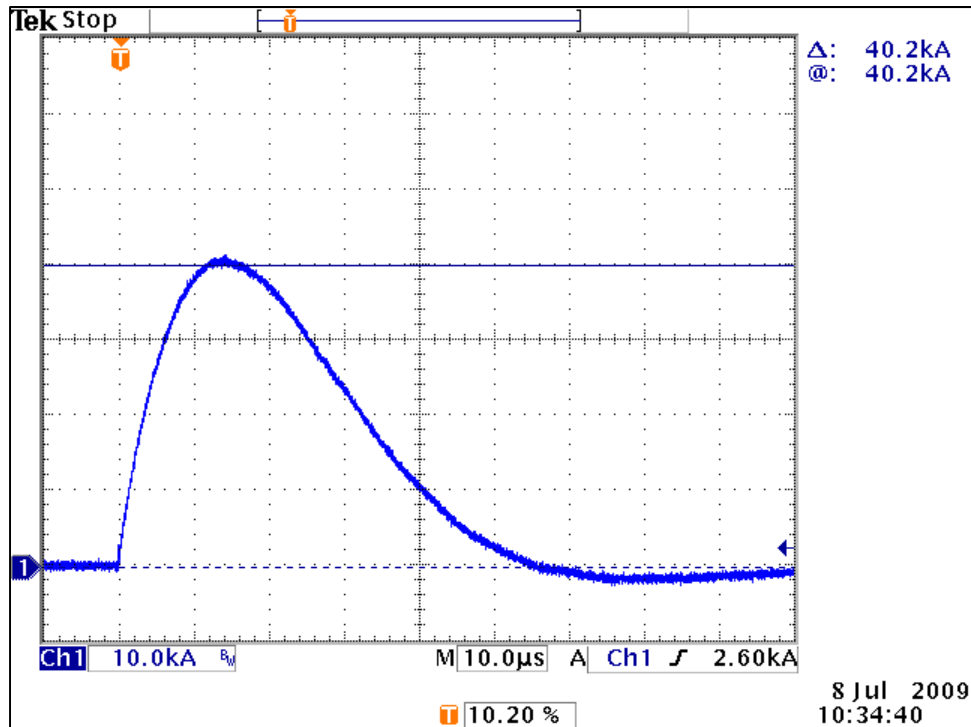
Figure 2 – Typical Test Current Oscillogram
(Test No. 35 – 40 kA)

The surge current Component D waveform as defined in SAE ARP5412 had a time to crest of 13 μ s and tail time (return to 50% of crest) of 32 μ s. Figure 2 is a typical current pulse oscillogram. The applied currents started at 7 kA and increased in \sim 5 kA steps until a failure occurred.
